# Building Survey Report

Hill View  
10 Low Road  
Hampton  
Leicestershire  
HX22 4TQ

7th September 2018

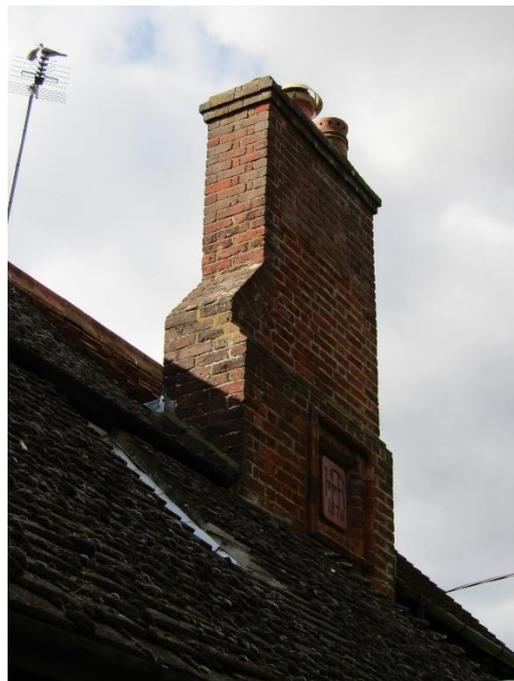
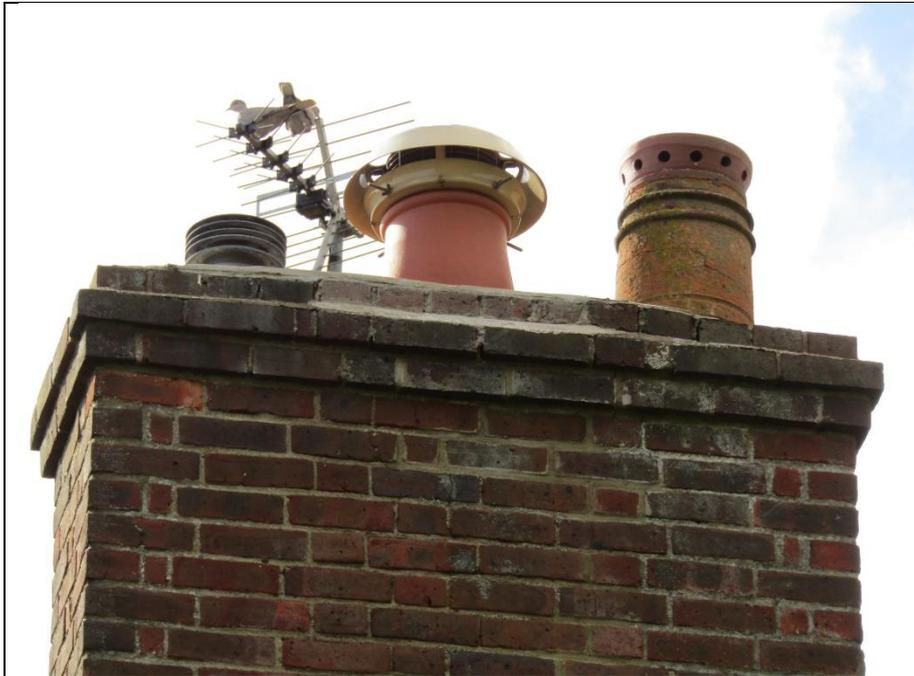
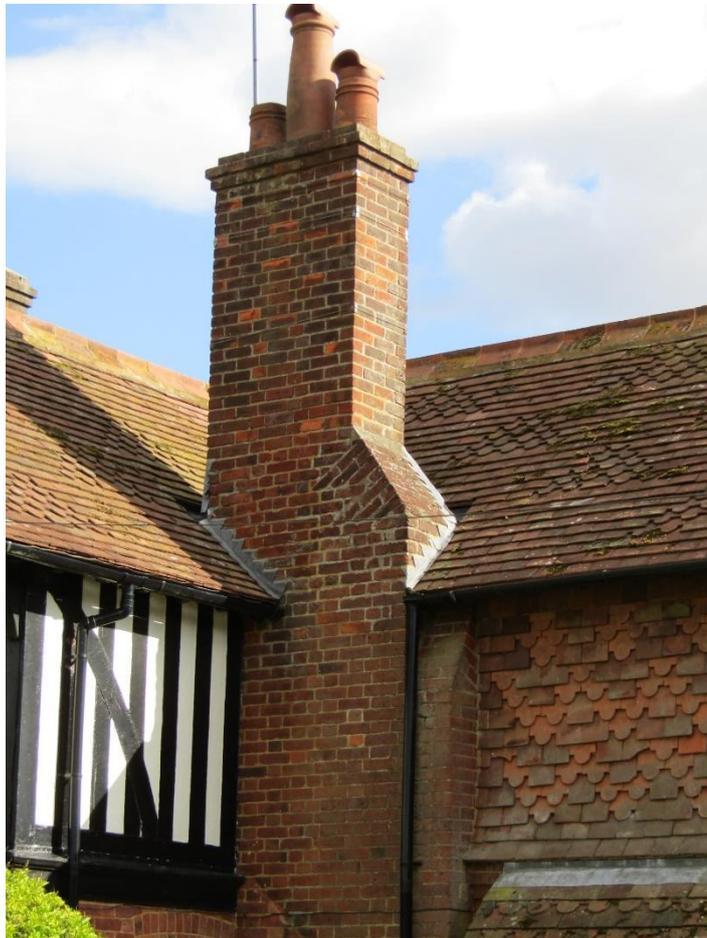
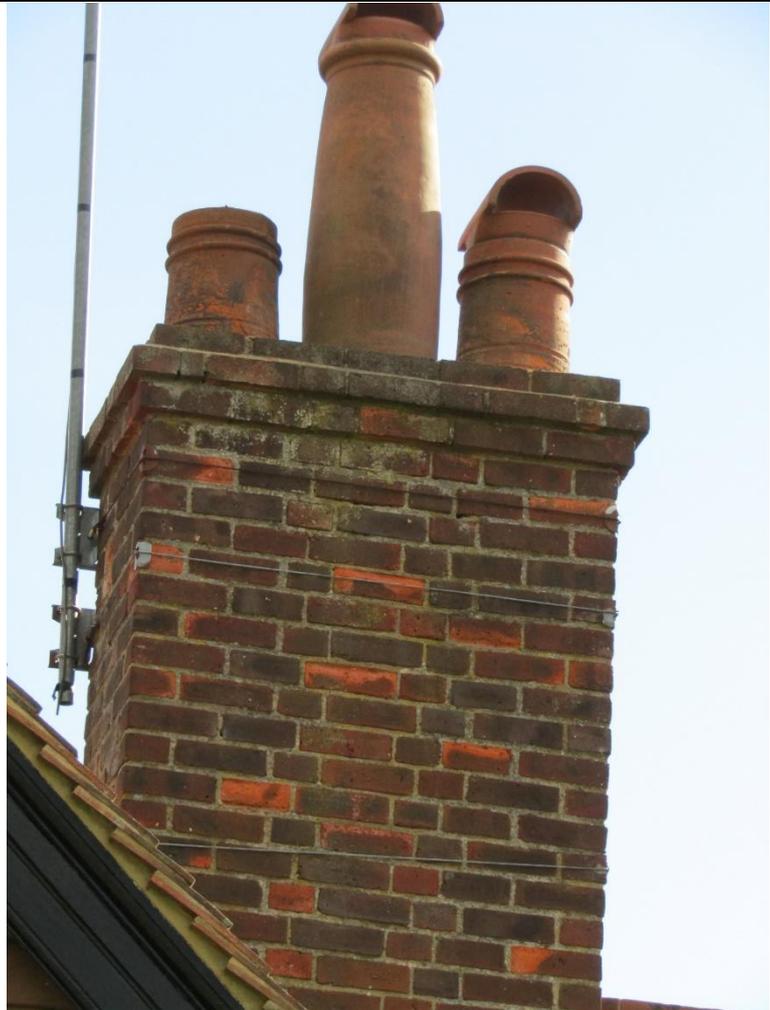
1. The stacks show normal effects of age and weathering. No significant damage or deterioration was noted. The stacks have been renovated in later years. The stack should remain serviceable providing regular maintenance checks are carried out.

This is a standard type of chimney stack construction in a building of this age and type. On the whole, this part of the building is in average and acceptable condition when compared to those homes and buildings of a similar age and type. **Condition Rating 1.**

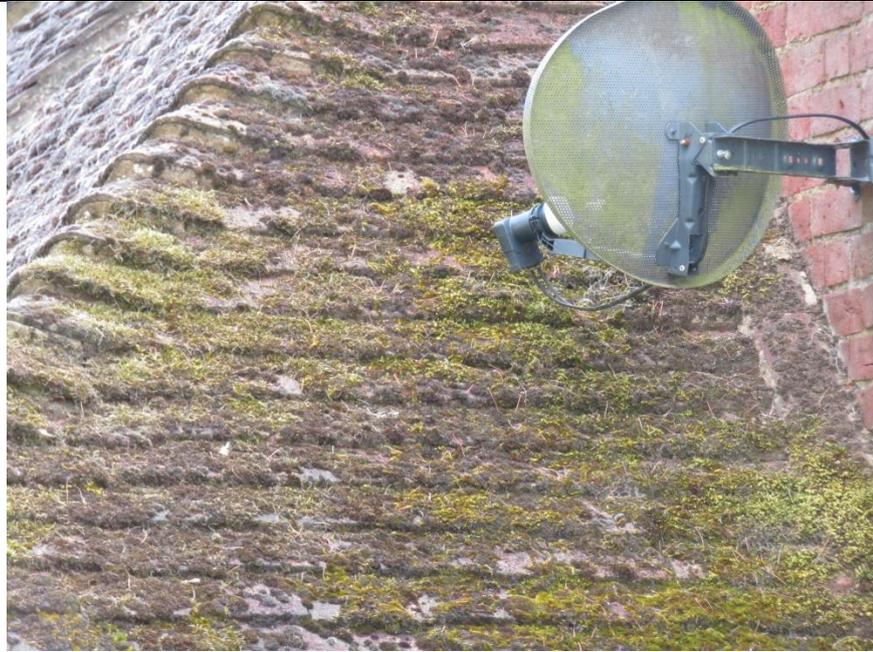
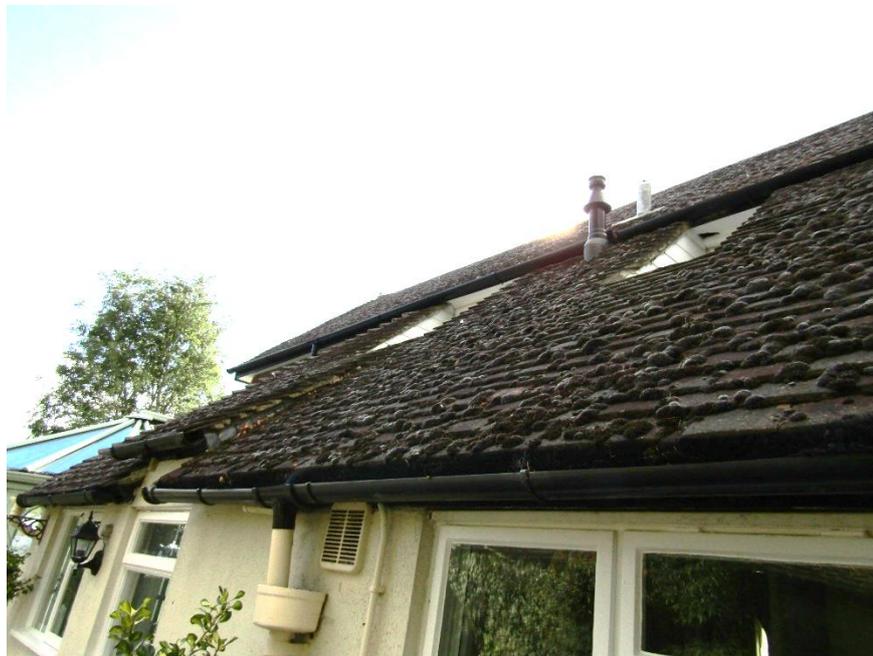
3. The flat leaded sections over the side kitchen extension have leaked in the past causing the timbers inside the loft to deteriorate. This looks as though it has been repaired and appeared dry but keep an eye on this. See Section F1.
4. Hole in the eaves board needs checking and closing off as this may allow vermin to enter.

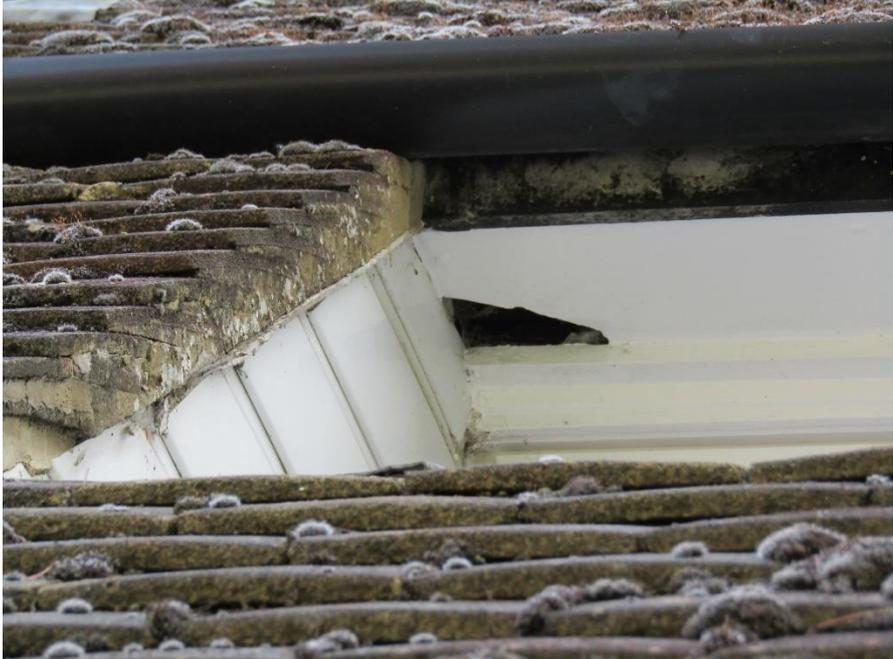
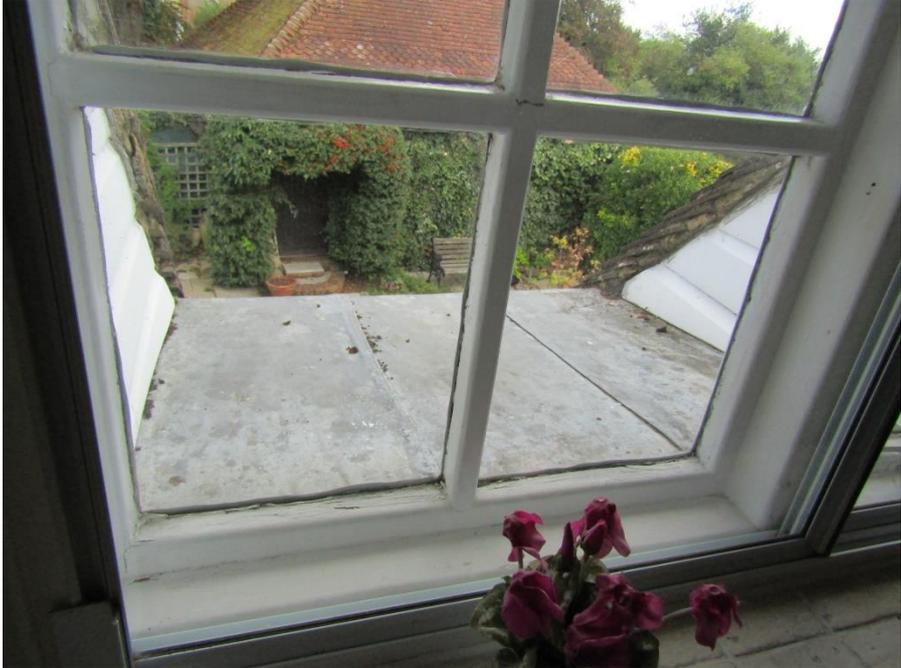
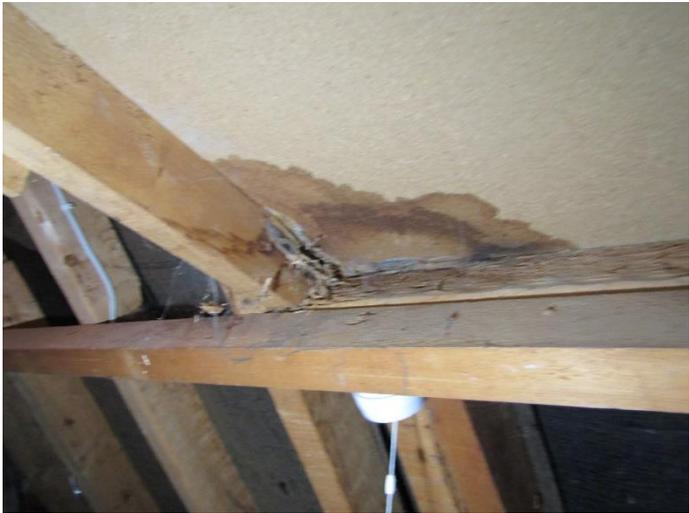
Stains from previous leaks

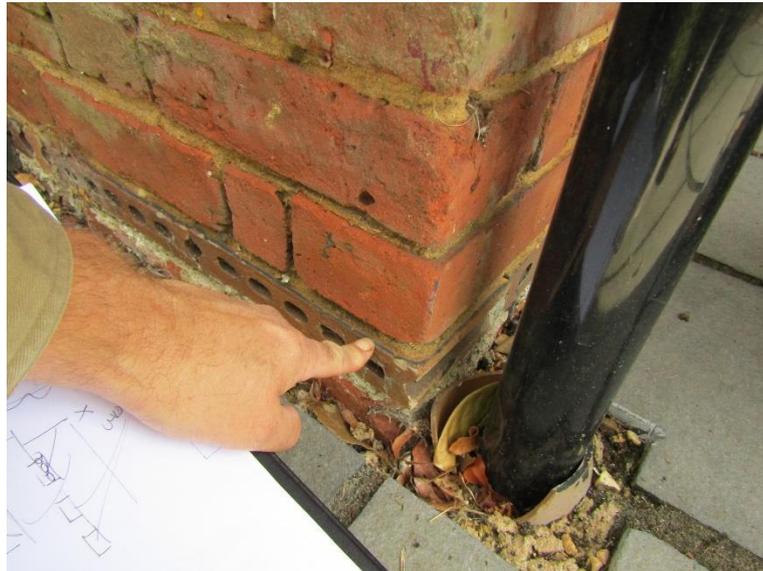
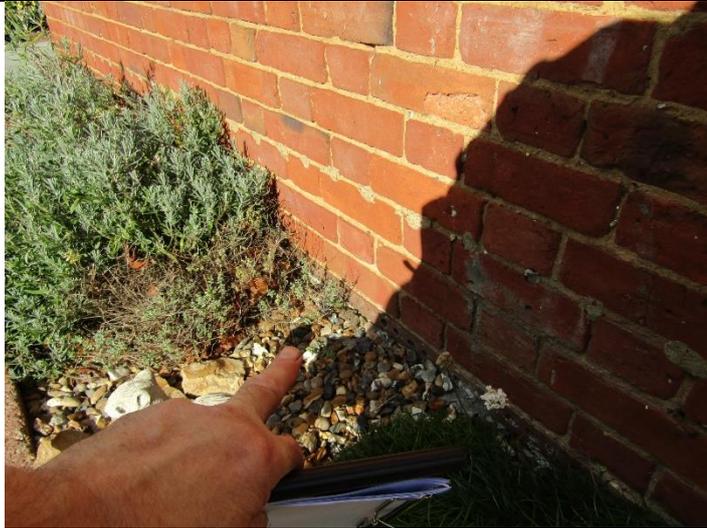
Chemical damp proofing

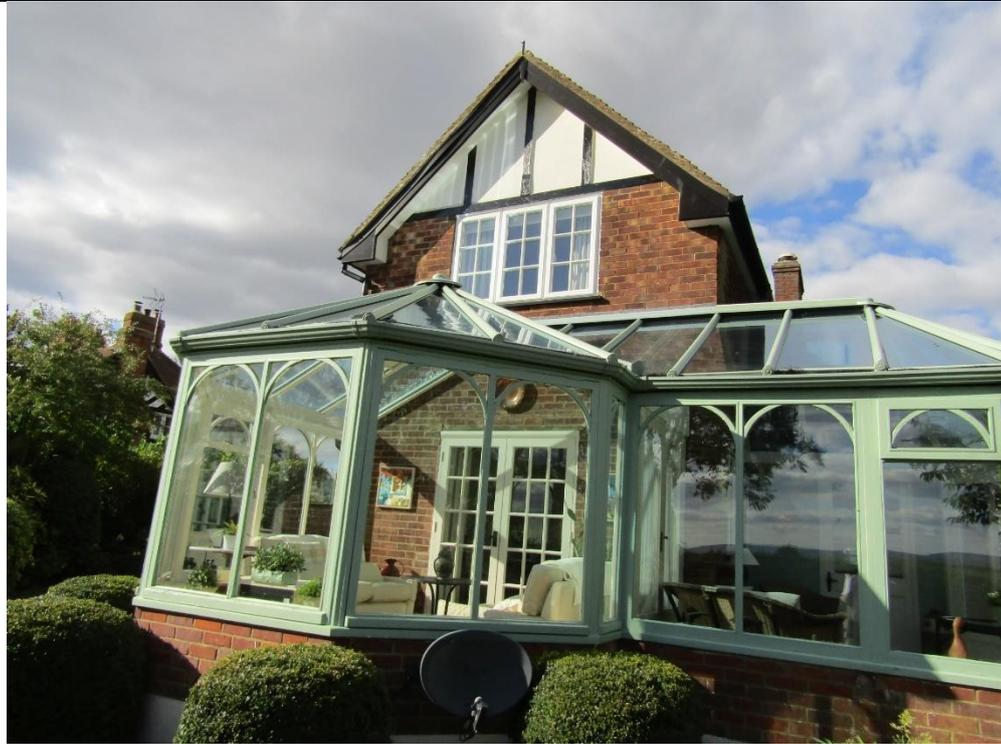
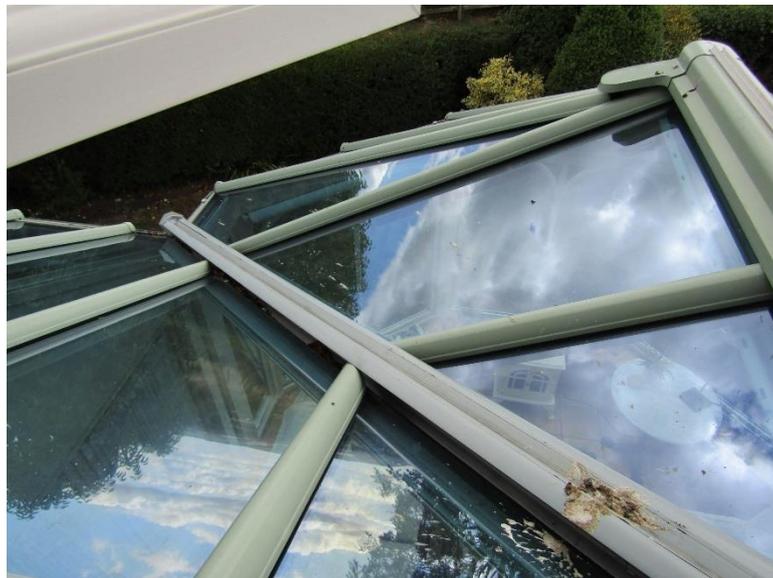
Replacement double glazed roof

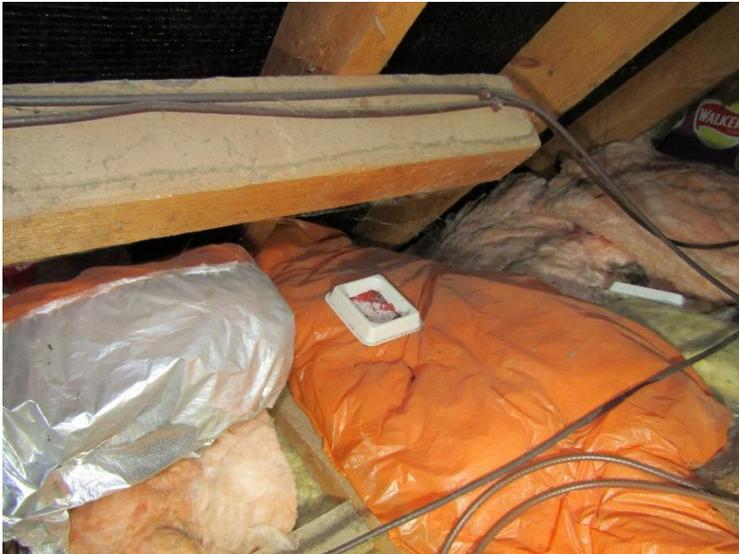
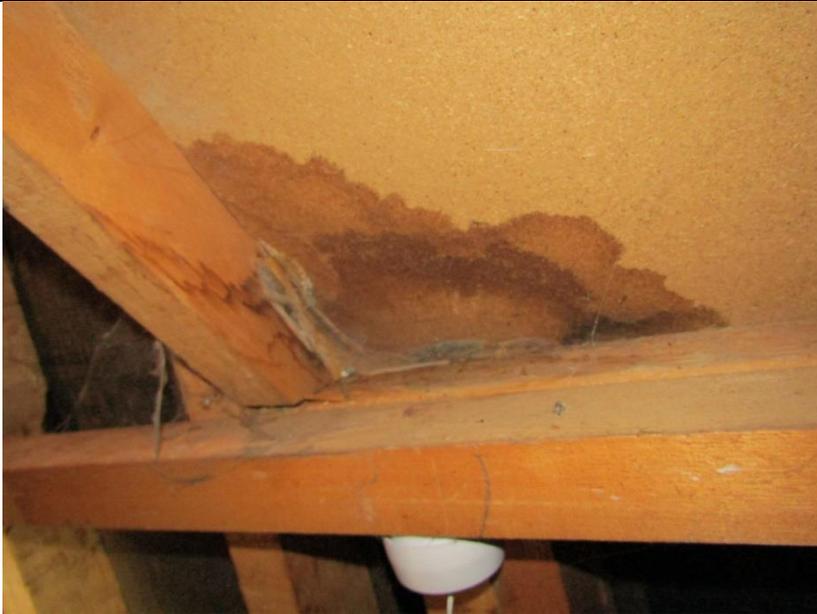
4. There is evidence of past water leaks over the side kitchen/flat roof sections. The timbers have deteriorated from minor rot. This should be treated and monitored.

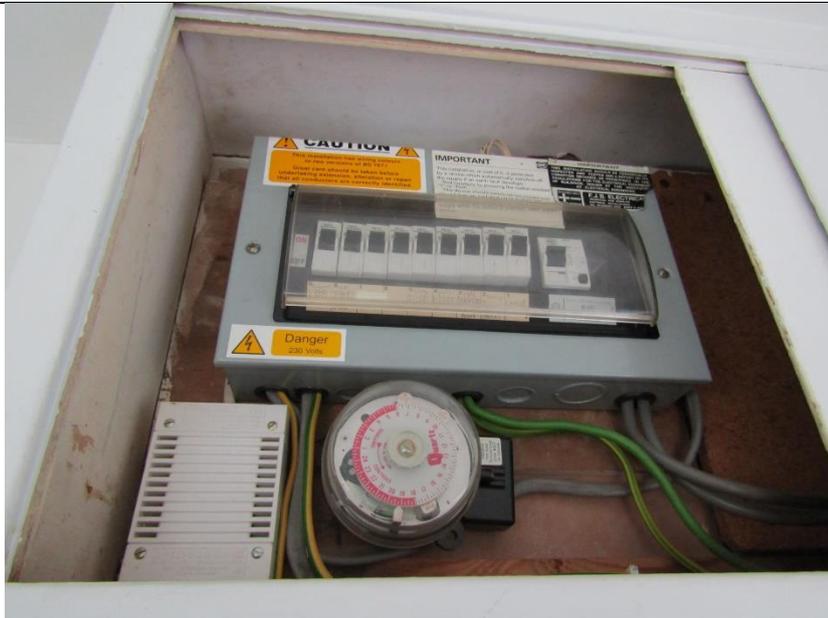
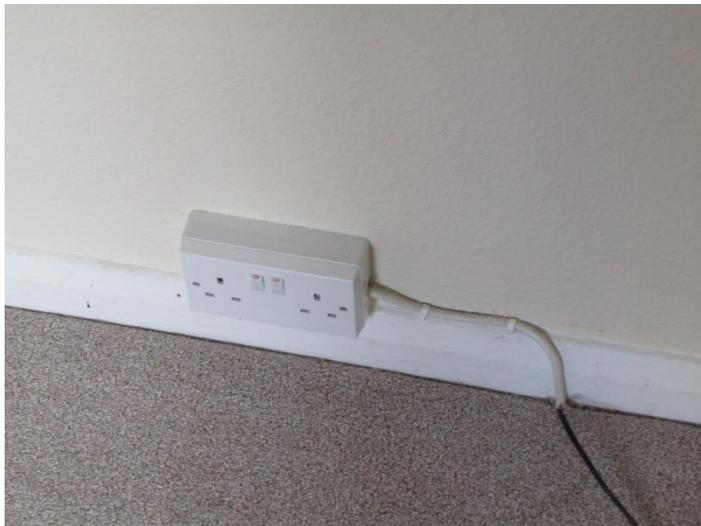
Sockets added on

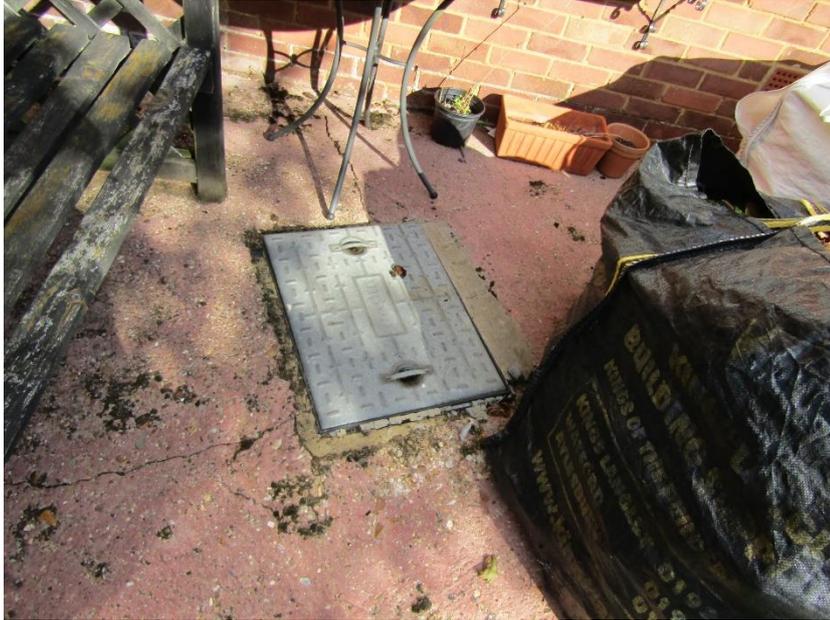
Cover needs securing
