Survey level two: HomeBuyer report - Survey and Valuation

68 Lowe Avenue
Hampton
Derbyshire
DE85 7ET

10th August 2018

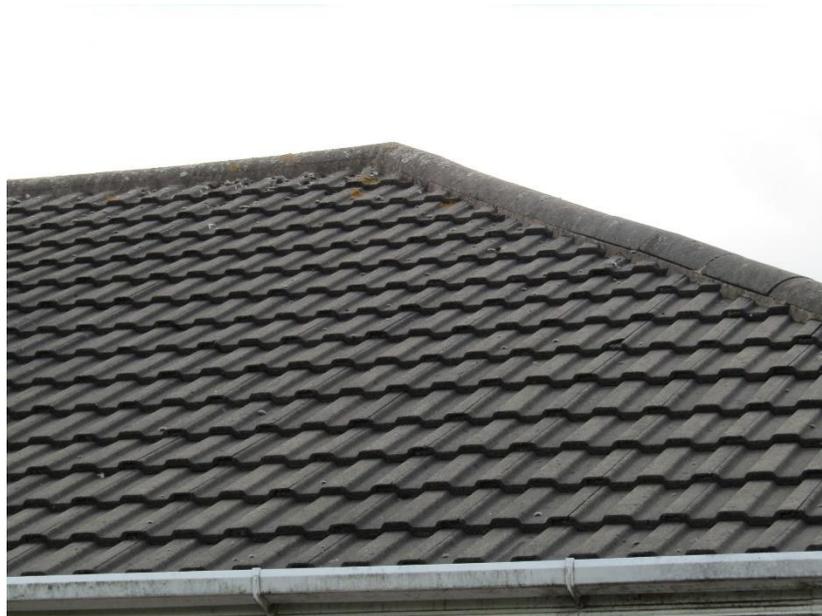
The tile coverings do show general effects of wear, age and weathering. This is considered quite normal.

No significant damage or deterioration was noted.

There is no evidence of serious water ingress and there is no obvious indication of urgent or significant defects. Coverings should remain serviceable providing normal maintenance is undertaken. **Condition Rating 1.**

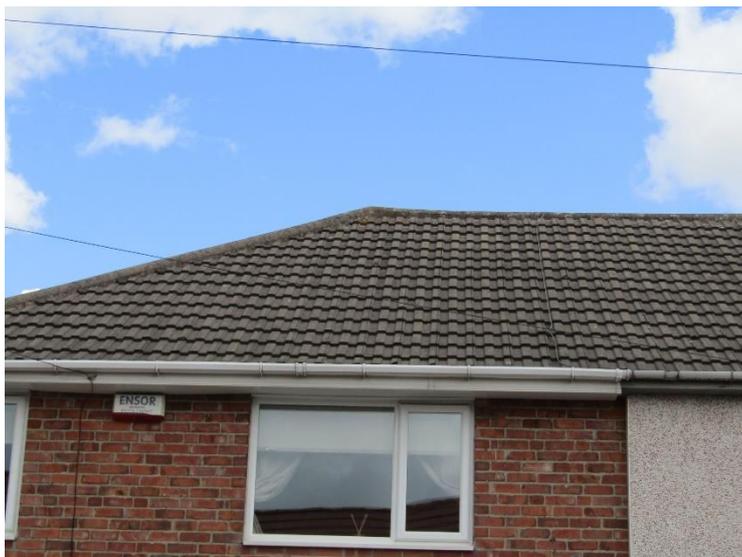
No significant defects were found. Normal cleaning maintenance should be undertaken.

Condition Rating 1.

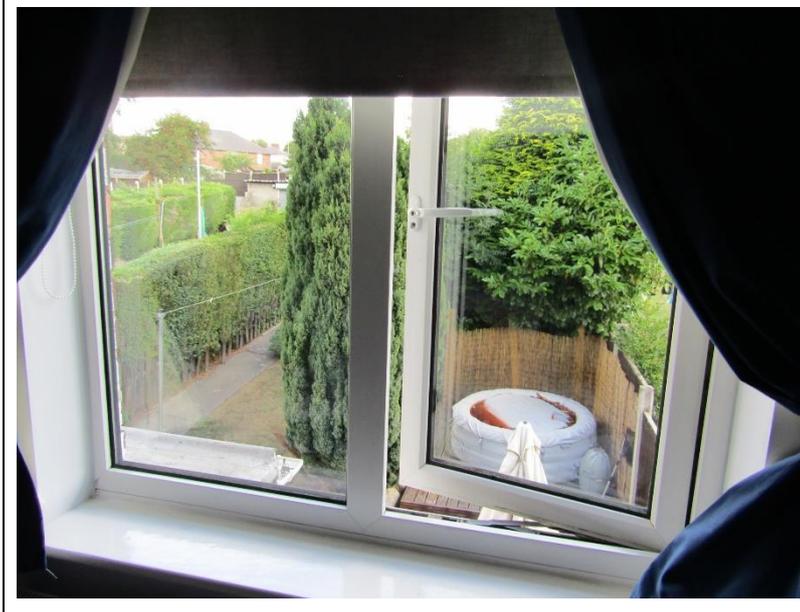
The window units were found to be generally serviceable when randomly tried under normal operation. There are no indications of urgent or significant defects. Window fittings should be regularly checked, cleaned and oiled to ensure they are maintained in the normal way. Normal maintenance should be undertaken. **Condition Rating 1.**

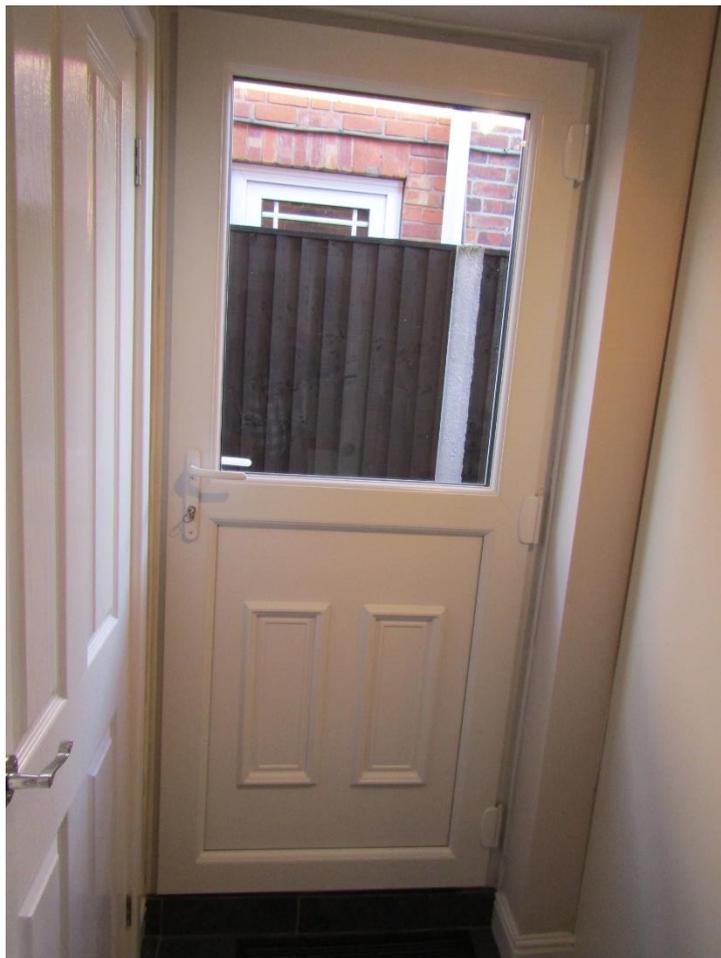
The doors and associated fittings were found to be generally secure and serviceable when randomly tried under normal operation. There are no indications of urgent or significant defects.

Condition Rating 1. Door fittings and locks should be regularly checked, cleaned and oiled to ensure they continue to function in the normal way.

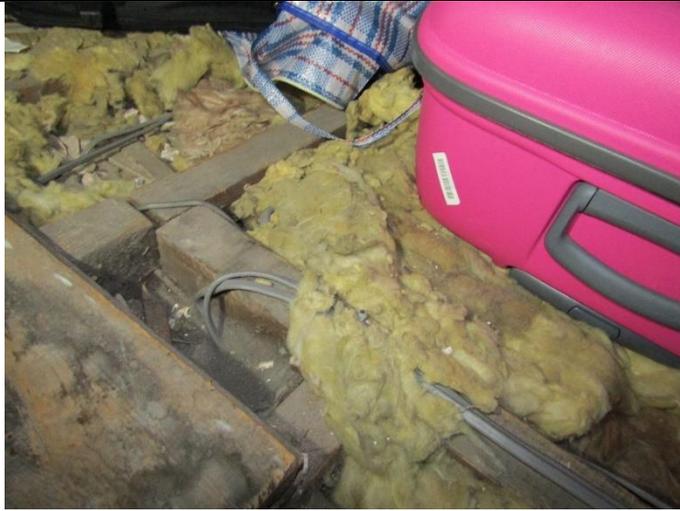
Insulation needs improving

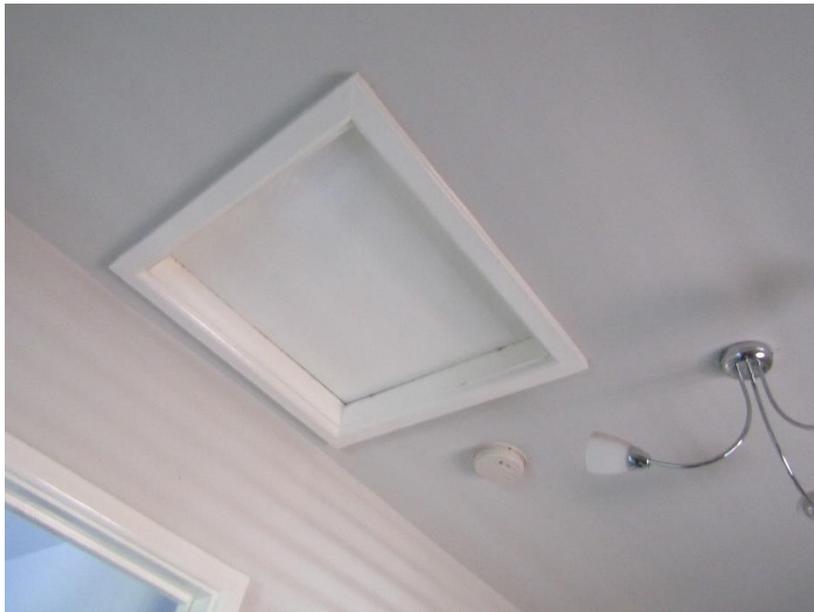
Ceilings look reasonably firm and secure from far as I can see with no signs of any serious damage or weakness. **Condition Rating 1.**

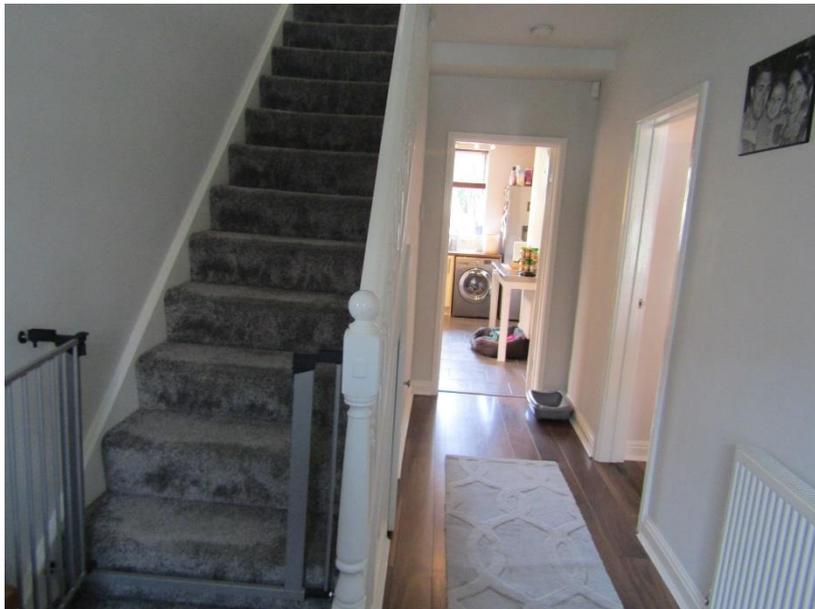
There are no indications of urgent or significant defects. Normal maintenance should be undertaken. **Condition Rating 1.**

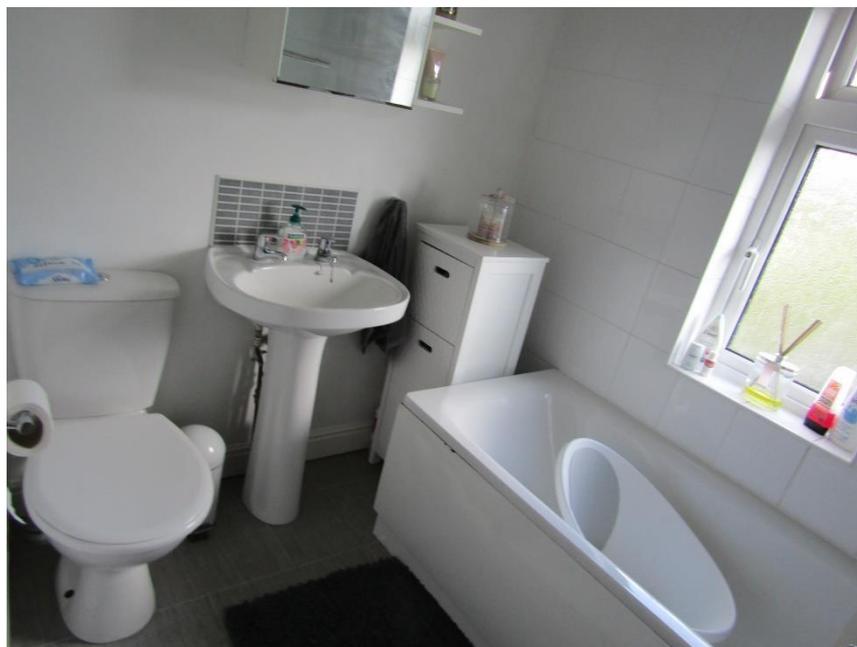
Fittings appear to be adequately fixed in position. Sanitary fittings are of a basic, acceptable standard for the scale and style of the dwelling. Fittings appeared serviceable when tried under normal operation. **Condition Rating 1.**

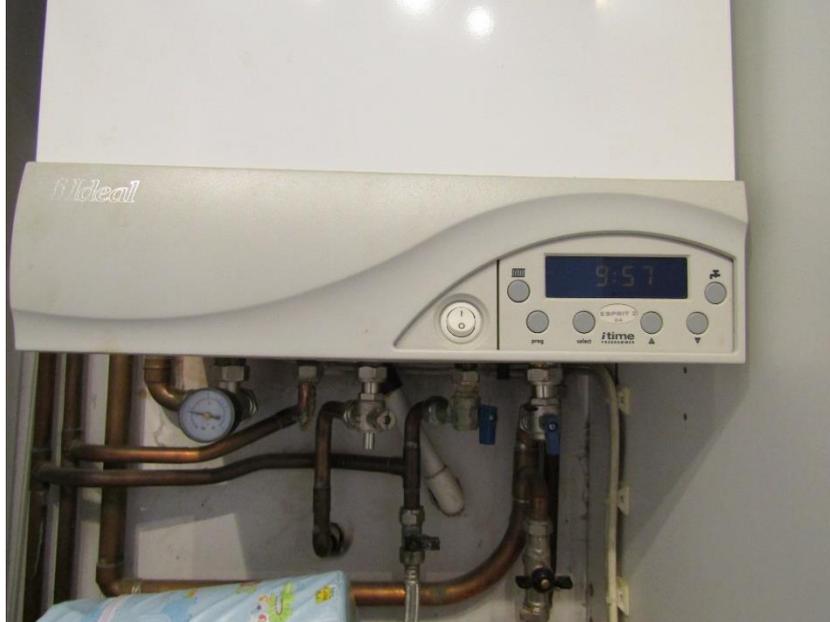
There are no visible signs of any significant defect with the installation (i.e. active leaks, stains or visible serious damage). **Condition Rating 1.**

Action: Your legal adviser should inquire about boiler service and installation records. If not available, the system should be checked by a registered heating engineer.

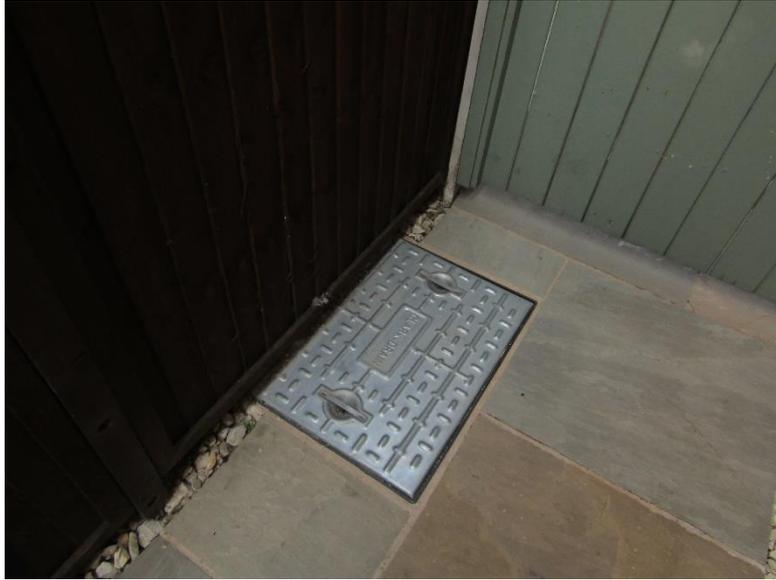
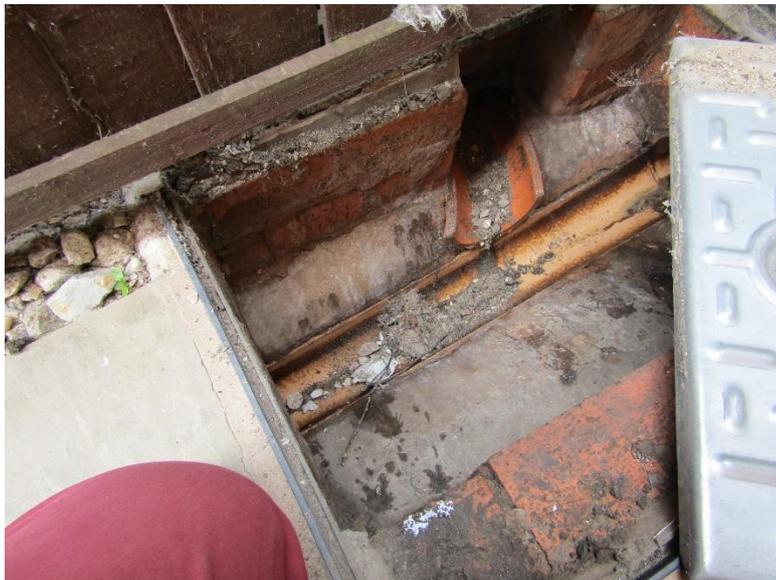
Some debris was noted lying at the base of the pipe in the chamber. This needs to be checked and cleared out under maintenance. **Condition Rating 2.**

Debris needs clearing
