Survey level two: HomeBuyer report - Survey and Valuation

68 Lowe Avenue
Hampton
Derbyshire
DE85 7ET

10th August 2018

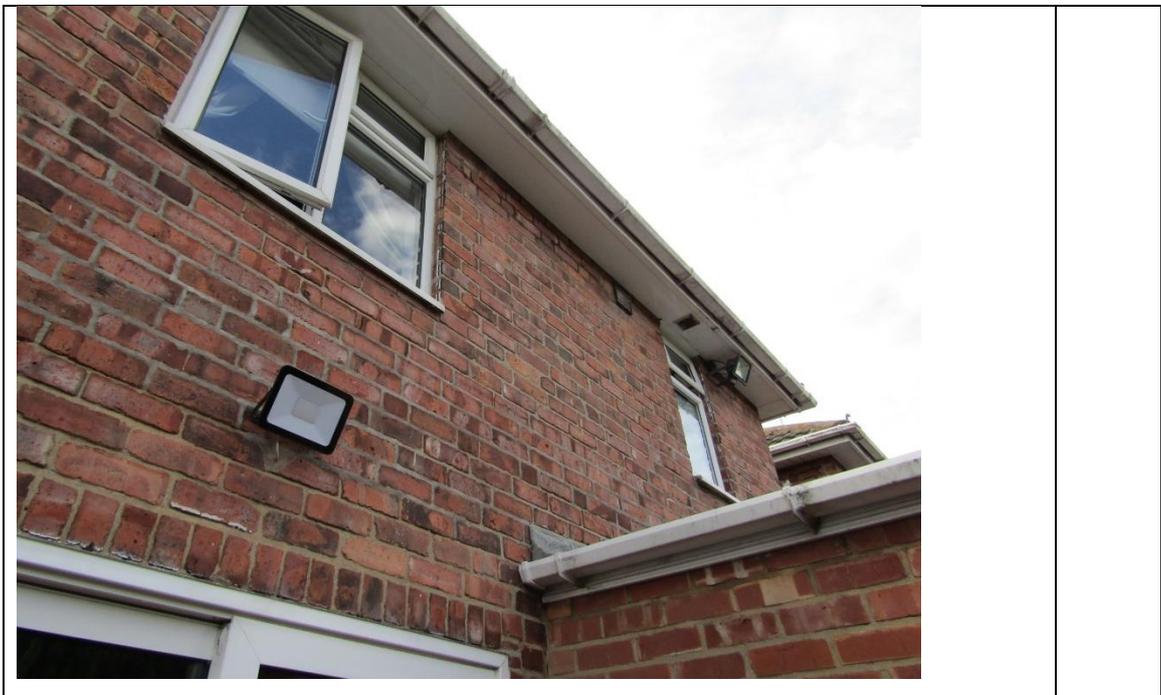
E4 Main walls

The original main walls are solid brick construction which is typical for a property of this age and type. The rear kitchen extension/alteration looks as though it is formed in cavity brick construction.

There is no significant deterioration or damage to the wall surfaces.

I found no signs of any serious cracking or distortion within the building to indicate instability. There are no obvious indications of any recent significant structural movement defects. See Risks J1.

There are no indications of urgent or significant defects. **Condition Rating 1.**

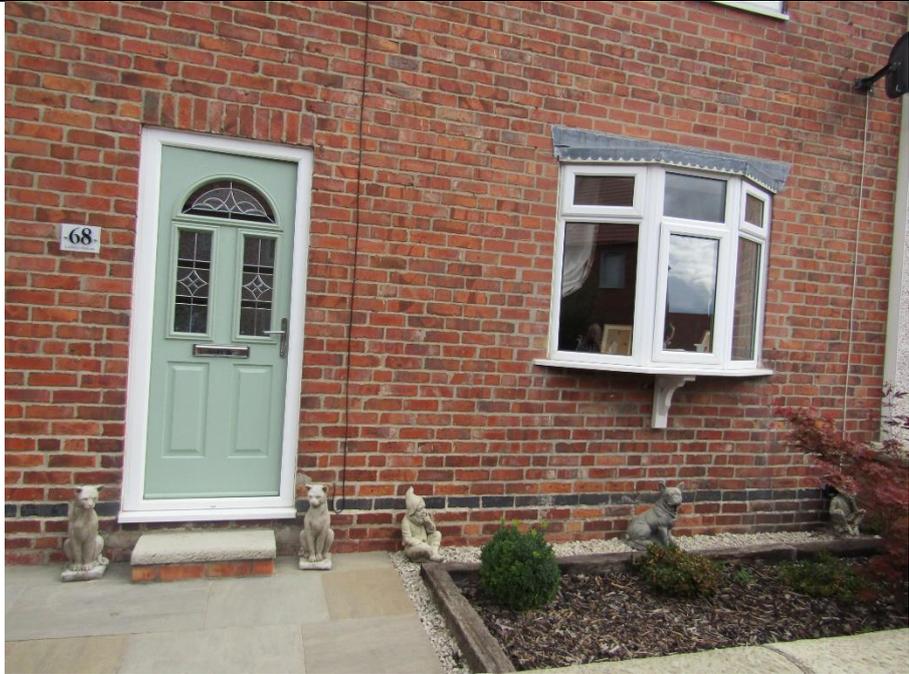
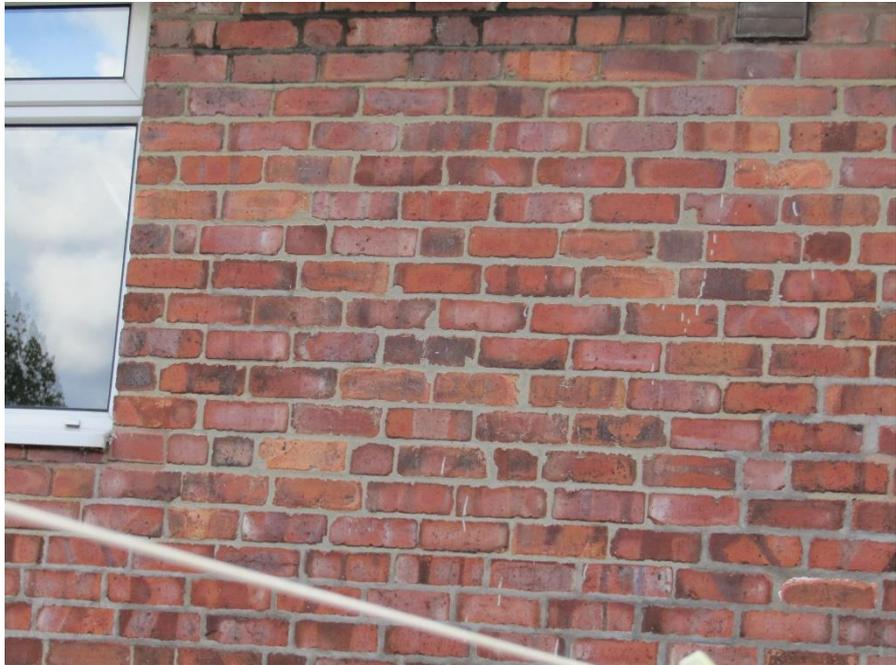
The original walls incorporate blue dense brickwork supplemented by chemical damp proofing.

On this occasion I found the damp proofing measures to be generally effective. There are no indications of urgent or significant defects. Occasional checks should be made and this part of the property must be maintained in the normal way. **Condition Rating 1.**

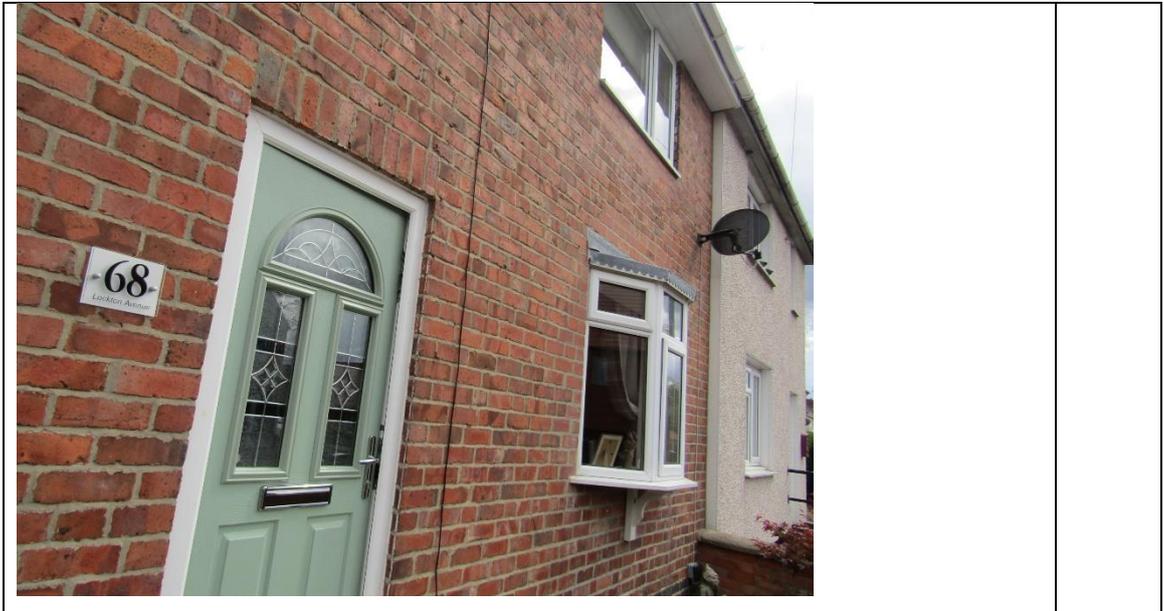
E6 Outside doors (including patio doors)

The front has a recent composite panel replacement door. The side and rear incorporate PVC and a double glazed sliding patio door.

The doors and associated fittings were found to be generally secure and serviceable when randomly tried under normal operation. There are no indications of urgent or significant defects.

Condition Rating 1. Door fittings and locks should be regularly checked, cleaned and oiled to ensure they continue to function in the normal way.
